Kielty Arborist Services LLC

June 19, 2018

Site: 633 O'Neill Avenue, Belmont CA

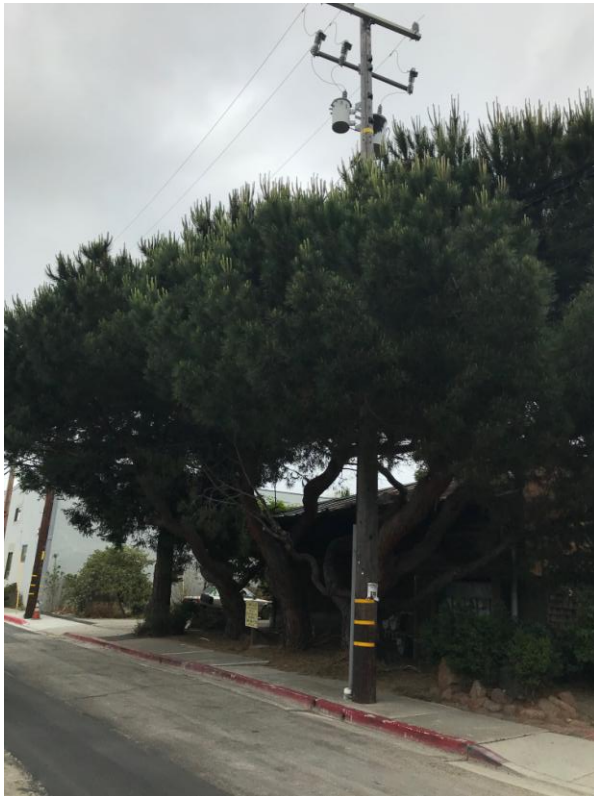
Showing trees in question underneath utility lines

The trees on site are a mix of imported trees to this area. These trees may be considered street trees as they are in close proximity to the existing sidewalk. All four trees surveyed are directly underneath high voltage utility lines and have been topped for line clearance. These trees should have never been planted in this area as there is not enough vertical room as well as not enough rootable area for these trees. The Italian stone pine trees have developed large lateral leaders that are at high risk of failure due to the constant line pruning. The trees have also been pruned for building clearance. Removal is recommended for all 4 trees as they are at high risk of interrupting utility services. Also, the Italian stone pine trees are at high risk of leader failure and should be removed. The trees also need to be removed as a new multi family building is proposed.

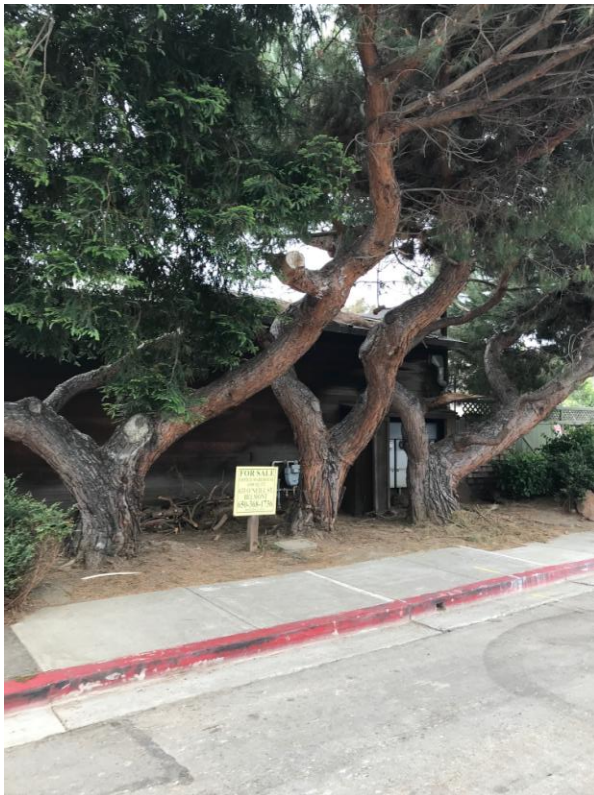
Tree#	Species	DBH	CON	HT/SP	Comments
1P/R	Italian stone pine (<i>Pinus pinea</i>)	30.1	40	30/35	Fair vigor, poor form, topped for utility line clearance, heavy lateral leaders, pruned over building in past, small rootable area for species.
2P/R	Italian stone pine (<i>Pinus pinea</i>)	26.8	40	30/35	Fair vigor, poor form, topped for utility line clearance, heavy lateral leaders, pruned over building in past, small rootable area for species.
3P/R	Italian stone pine (<i>Pinus pinea</i>)	31.6	40	30/35	Fair vigor, poor form, topped for utility line clearance, heavy lateral leaders, pruned over building in past, small rootable area for species.
4P/R	Redwood (<i>Sequoia sempervirens</i>)	16.2	40	30/15	Fair vigor, poor form, topped for utility line clearance, small rootable area for species.

Showing heavy lateral leaders

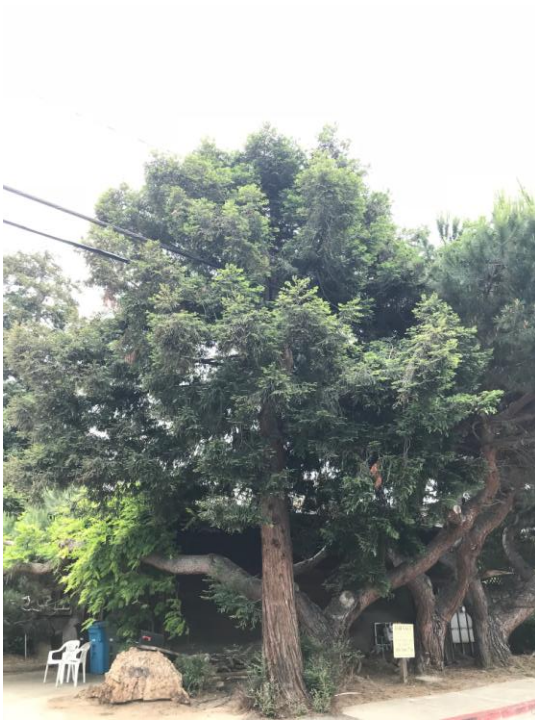
Showing topped redwood tree

The city of Belmont will likely require replacement trees. If the replacement trees are to be planted below the utility lines, they should be PG&E approved trees for growing underneath utility lines(a maximum height of 25 feet).
